CALIFORNIA GEOLOGY

COASTLINE EROSION

SANTA CRUZ COUNTY

GARY B. GRIGGS and ROGERS E. JOHNSON, Geologists
University of California - Santa Cruz, California

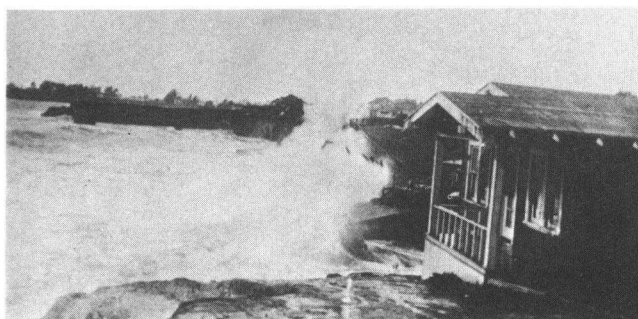
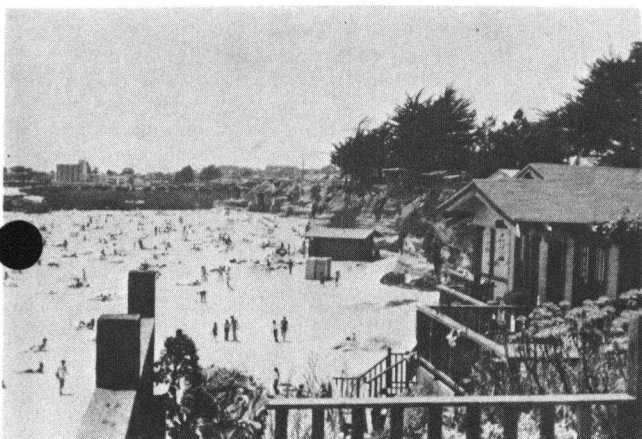
Figure 1. Coastline of northern Santa Cruz County.

The city of Santa Cruz lies on the northern edge of Monterey Bay along the central California coast (figures 1, 2). Uplifted marine terraces flank most of the northern bay and also the open coast to the north. The present seacliff varies in height from about 6 to 27 meters (m).

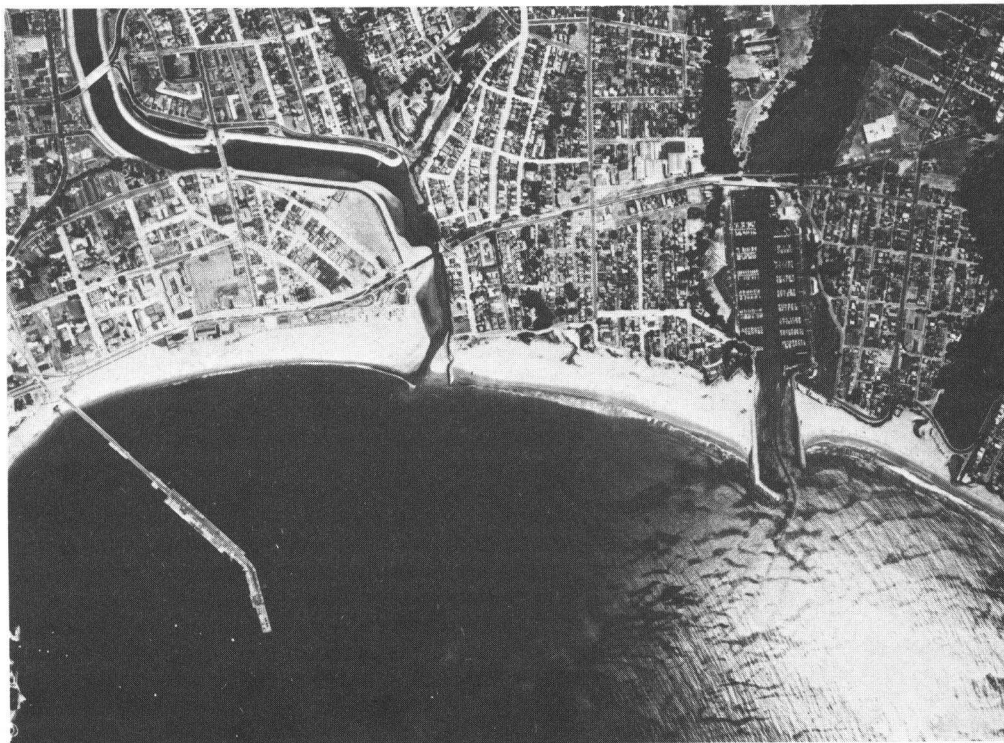
Figure 2. Aerial photo of the city of Santa Cruz on northern Monterey Bay, showing wide sandy beaches, San Lorenzo River, and small craft harbor. Note the wide beach to the west (left) of the harbor and the narrow beach to the east (right) of the harbor. Photo by California Department of Fish and Game, July 1969.

Monterey Bay (Griggs, and Johnson, 1976). A broad protective upcoast beach formed where severe erosion (up to 90 cm per year) had been occurring (figures 2, 13a, b). The interruption of littoral drift and loss of sand downcoast led to increased erosion, and private property owners had a buffer of riprap placed to prevent erosion along the ocean front. At Capitola, several miles downcoast, a groin was constructed to trap sand moving downcoast in order to form a protective beach. The existing beach disappeared following the upcoast construction of the harbor at Santa Cruz. The downcoast side of the groin is devoid of a beach and is adjacent to a vertical concrete wall which encloses a sewer pumping station. The lack of sand, combined with the concentration of wave energy immediately downcoast from the retaining wall, produces above average erosion rates (figure 10).

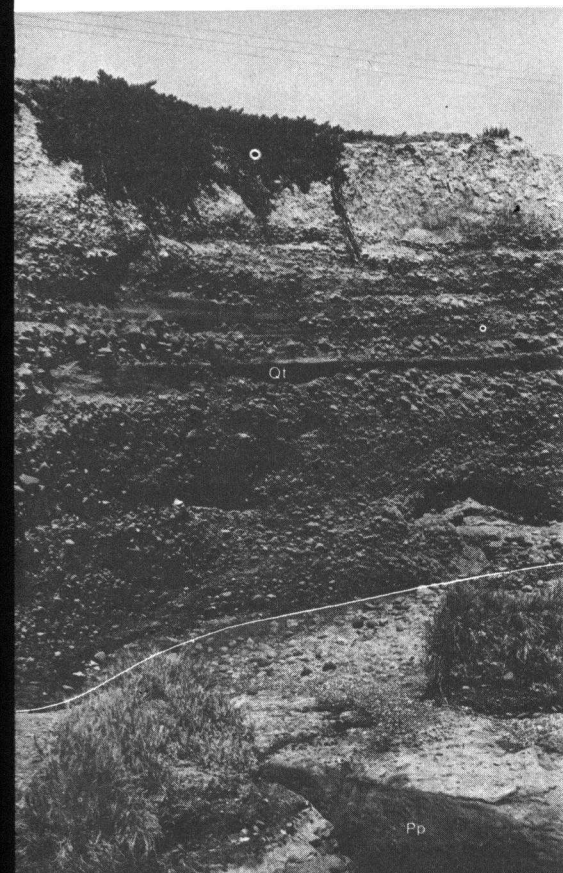
Figure 3. The seacliff along the northern portion of Monterey Bay. The Pliocene Purisima Formation (Pp), composed of siltstone, is capped by unconsolidated marine and nonmarine Quaternary terrace deposits (Qt). *Photo by G. B. Griggs*

The Mio-Pliocene Santa Cruz Mudstone and the Pliocene Purisima Formation (siltstone and sandstone) form the seacliffs throughout this area. These sedimentary rocks usually lie almost horizontal or dip gently seaward and are capped by 1.5 to 6 m of unconsolidated marine and non-marine Quaternary terrace deposits (figures 3, 4).

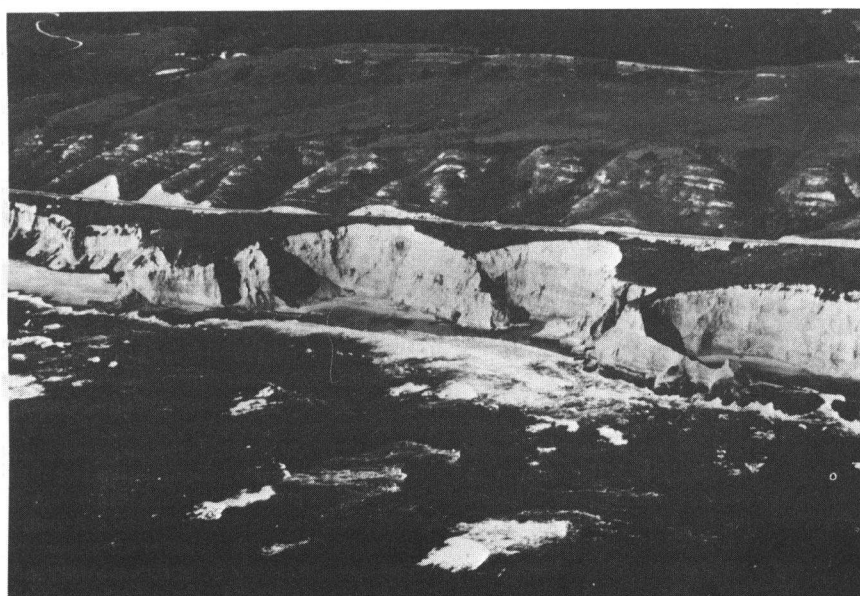
Figure 4. Coast of Santa Cruz County, north of Davenport. State Highway 1 follows the coastline. Tertiary sedimentary rocks form the steep eroded cliffs. *Photo by G.B. Griggs.*

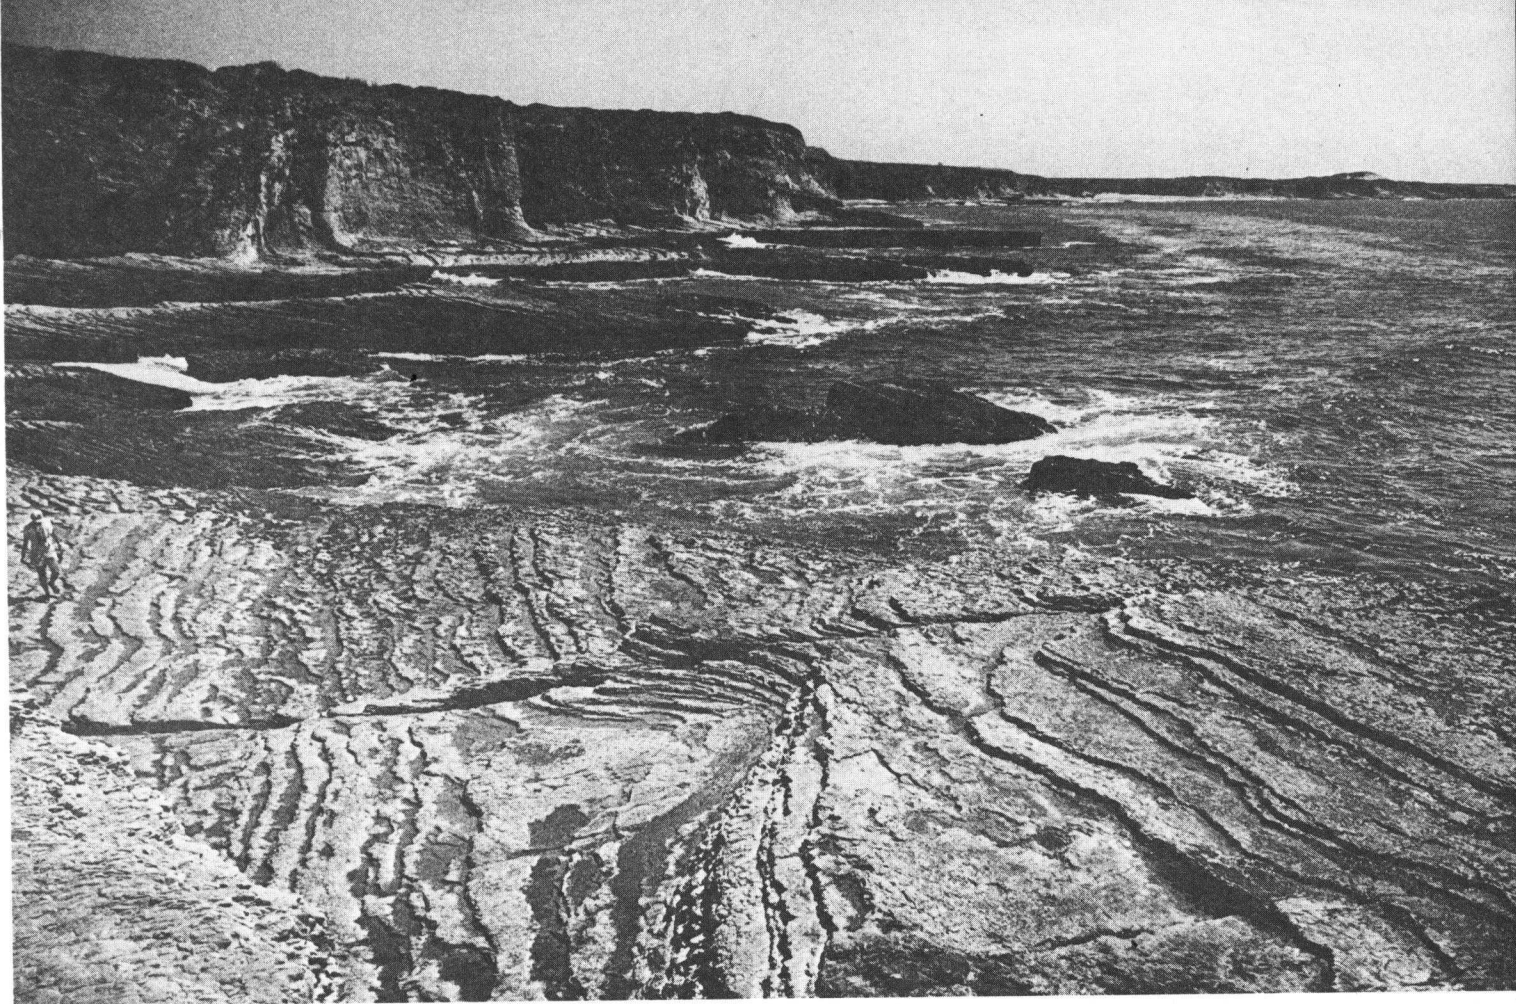
Figure 5. This coastal area is protected from wave action to some degree by a well-developed shore platform (foreground) formed by resistant beds in the Santa Cruz Mudstone. The formation dips seaward at this location just south of Davenport, Santa Cruz County. Photo by G.B. Griggs.

Seacliffs bear the brunt of the wave attack, although they are protected in some areas by shore platforms (figure 5). Shore platforms develop where bedding planes in the Santa Cruz Mudstone dip gently seaward, but are also found where dips are landward (Bradley and Griggs, 1976). At Natural Bridges State Beach, just north of Monterey Bay, the shore platform has formed by progressive erosion of the Santa Cruz Mudstone until a very resistant siliceous bed was encountered. This

resistant bed in the nearly flat-lying mudstone forms the upper surface of the platform.

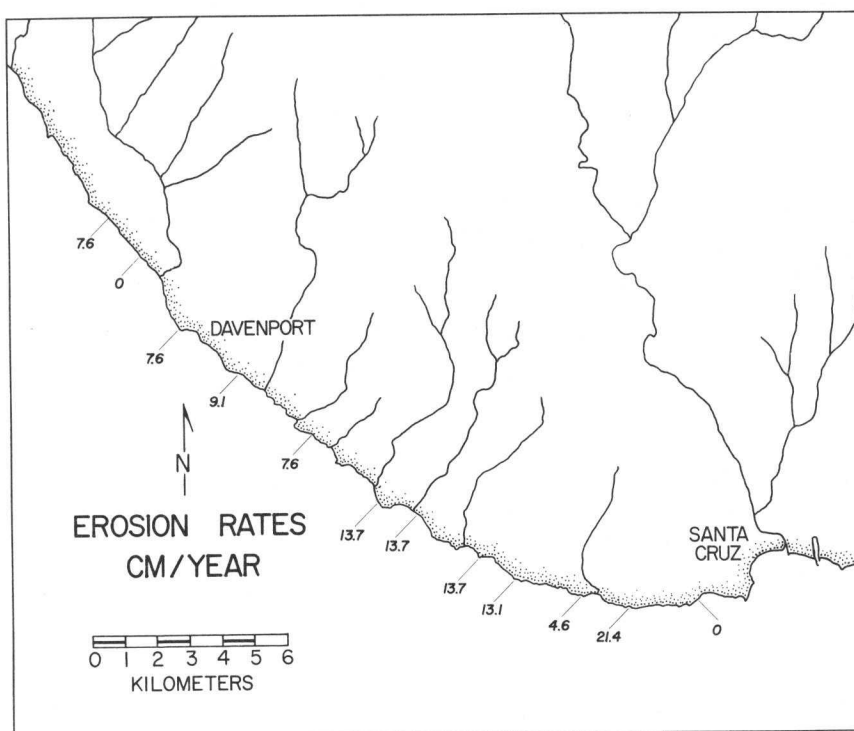
Figure 6. Average erosion rates along the northern coast of Santa Cruz County for the 20-year period 1943-1963. Measurements by R.E. Johnson.

Despite the direct exposure to strong wave attack, the resistance of the Santa Cruz Mudstone to the hydraulic impact of the waves and abrasion generally has produced only moderate rates of coastal retreat (figure 6). Between the city of Santa Cruz and the town of Davenport, 16 km to the north, aerial photo measurements (by the authors) at 13 sites indicate average values of 0 to 21.5 cm/year of cliff retreat over a 20 year period. Periodically an arch or sea cave in the seacliffs will collapse, which locally produces rapid retreat of up to 24 meters in some instances (figure 7a, b).

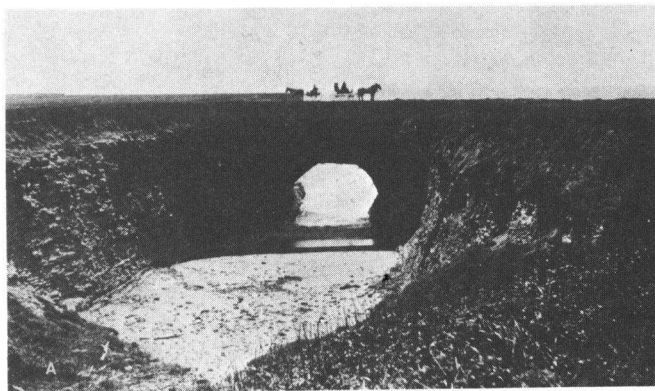
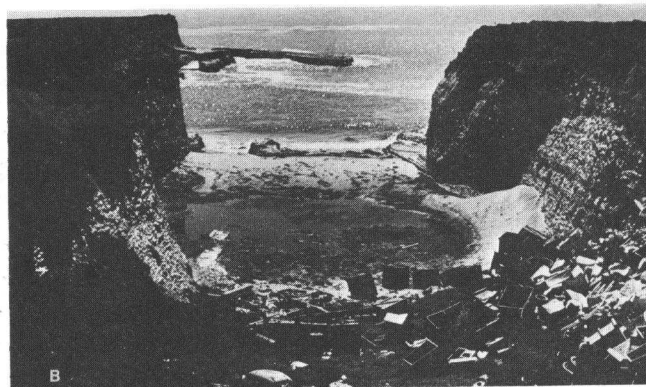
Figure 7. The collapse of an arch or sea cave in the cliffs along the coast contributes to the cliff retreat. A. This 1882 photo was taken at a site known as Wilder's natural bridge. B. The site of Wilder's natural bridge, 1973. *Photo by R.E. Johnson.*

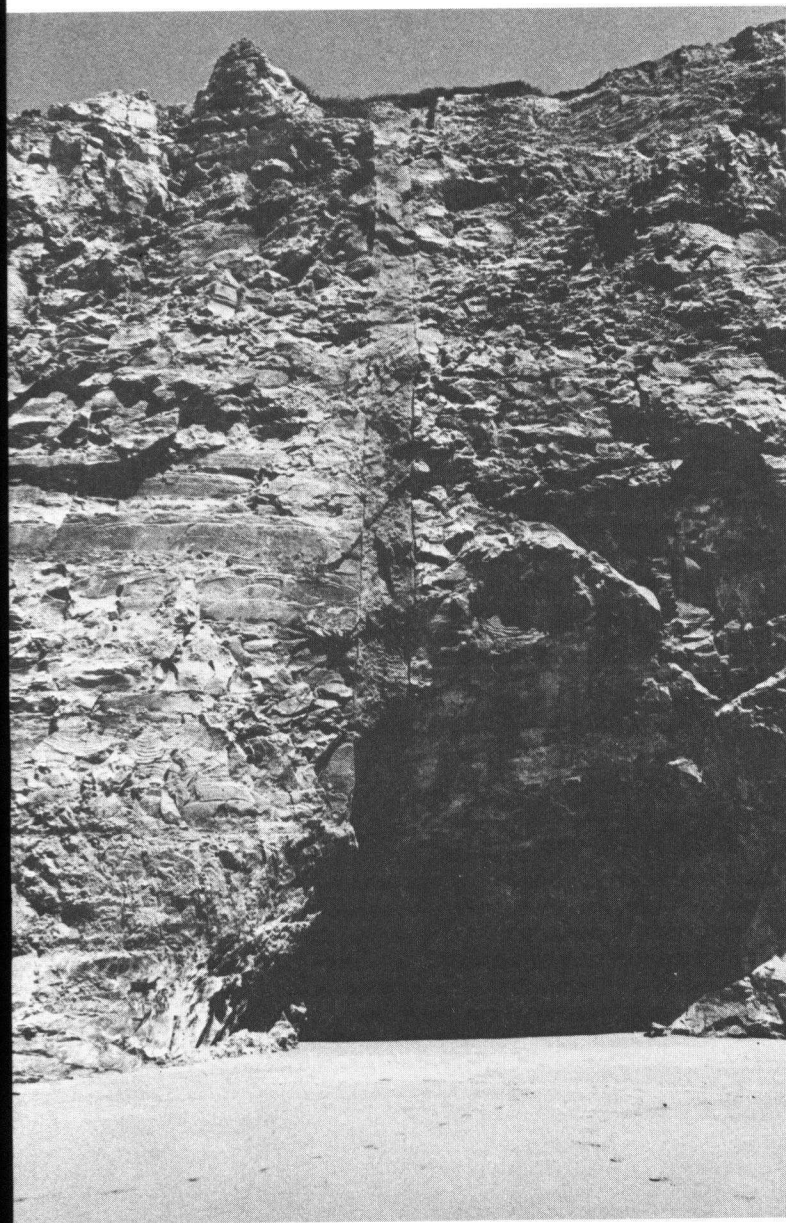
Figure 8. Sandstone intrusion in the Santa Cruz Mudstone, south of Davenport. The position of the intrusion has determined the location of the tunnel (dark area at lower right of photo). *Photo by G.B. Griggs.*

intrusions* commonly occur within the Santa Cruz Mudstone north of Monterey Bay. These intrusions probably were derived from the underlying Santa Margarita Sandstone, or possibly the sands in the older Monterey Formation. Many of the intrusions are saturated with hydrocarbons, and sandstone intrusions with both carbonate and ferruginous cement occur within the Santa Cruz Mudstone. Erosional resistance of the intrusions is dependent upon the size and location of the sandstone body, the nature of the contacts between the intrusion and mudstone, and the cementing agent. The location of erodible sandstone becomes a focal point for erosion and wave impact, creating arches, caves, and tunnels (figure 8). The differential resistance to erosion resulting from this lithologic heterogeneity has produced a variety of coastal landforms and consequently a scenic stretch of coastline.

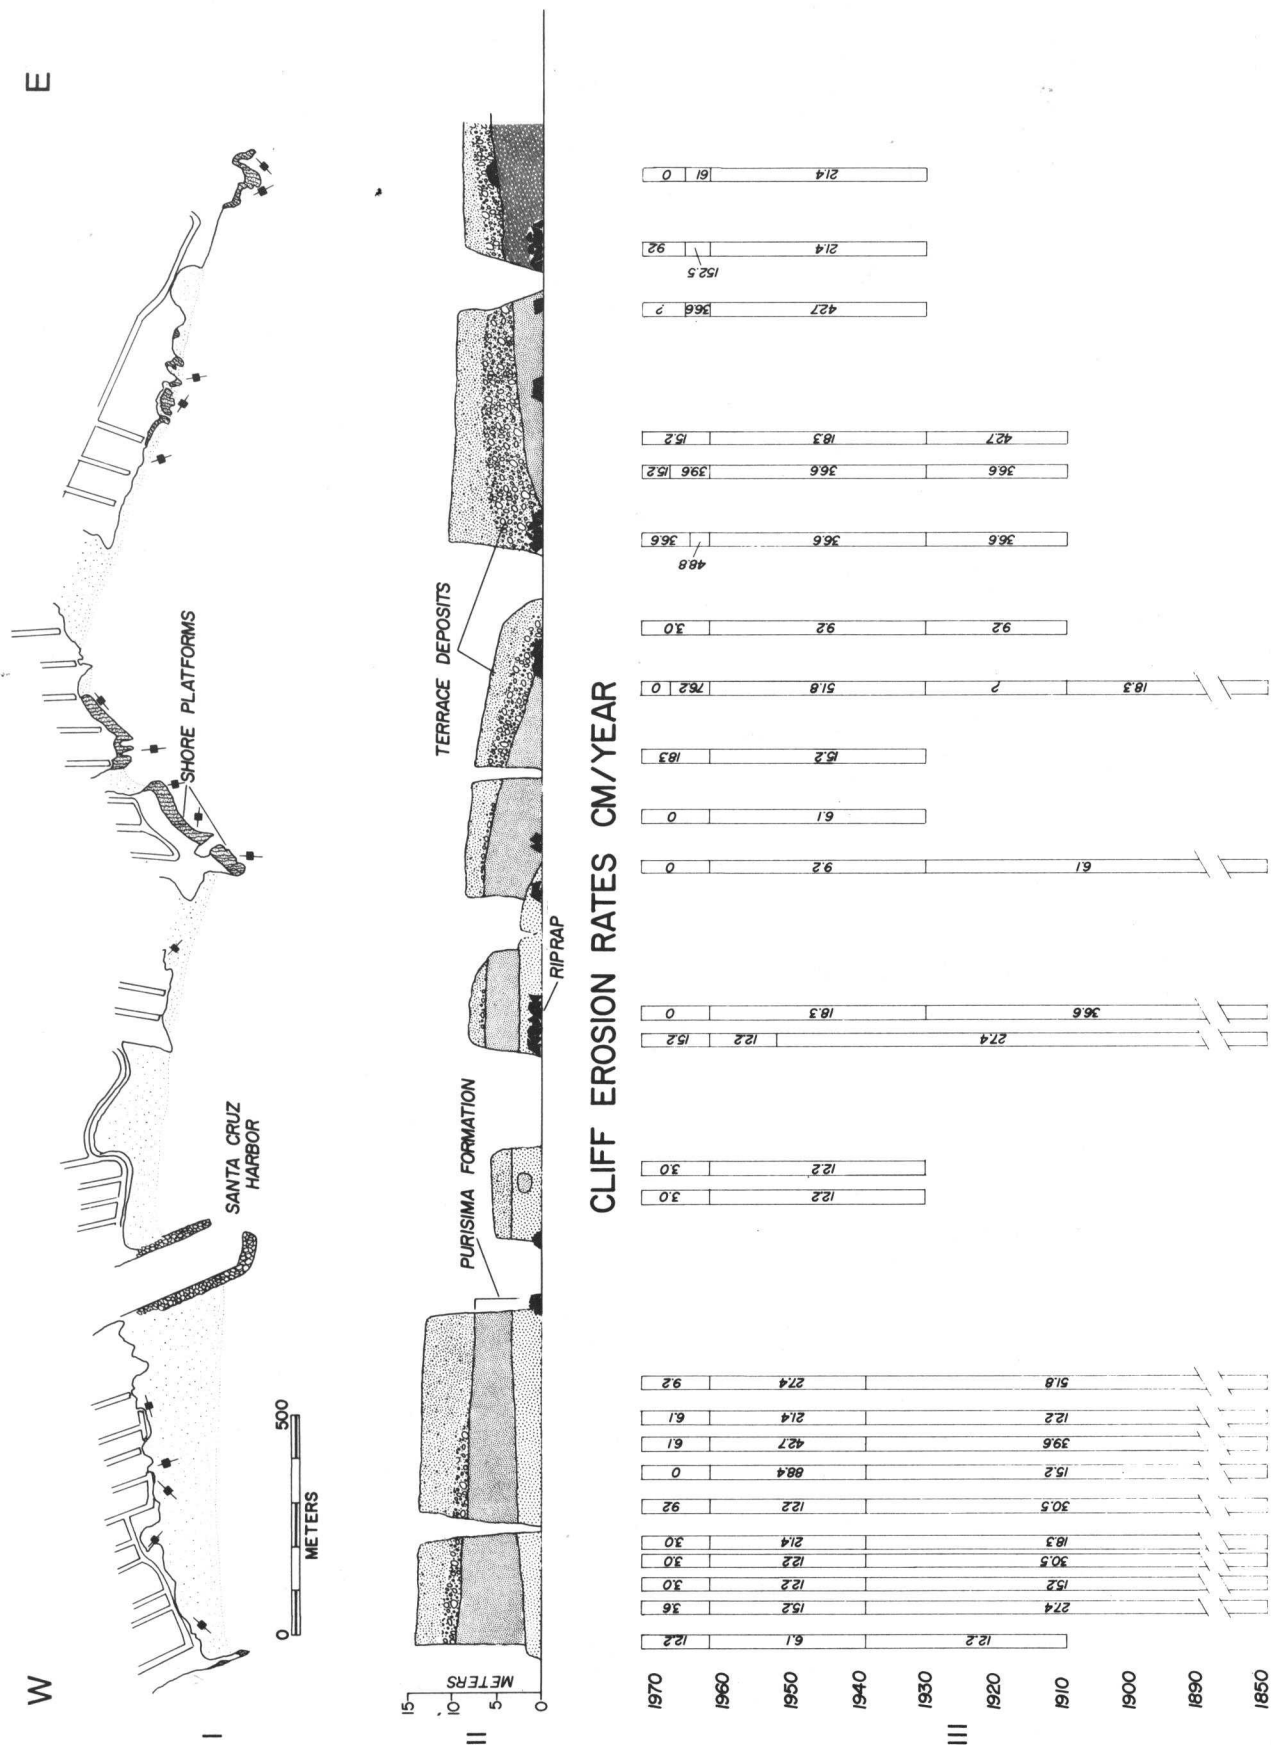
Figure 9. Plan view (I), cross section (II), and long term average erosion rates along northern Monterey Bay from San Lorenzo Point to Soquel Point (III). Note joint orientations on plan view and variations in elevation of terrace surface on cross section. Erosion rates are shown for specific intervals for which control exists.

Erosional resistance due to stratigraphic variation is very noticeable in the seacliffs, both within the Purisima Formation and along its contact with the overlying terrace deposits (figures 9, 10). Where unconsolidated or poorly indurated beds are exposed to surf action at the base of the seacliff, undercutting usually occurs in the form of notches, sea caves or arches, followed by collapse of the overlying material (figure 11).

of the Purisima Formation. Rapid erosion has cut back the cliffs, changing the trend of the coastline and creating the embayment known as northern Monterey Bay. Although the bay configuration protects this area from direct wave attack, erosion rates in these sandstone and siltstone beds (Purisima Formation) are still greater than the rates in the Santa Cruz Mudstone along the open coast to the north. The erosion rate of the Purisima Formation is influenced by the varying hardness of different lithologic units within the formation, the orientation of well developed joint sets, and the presence of faults (figures 9, 10).

The unconsolidated deposits which lie unconformably on the marine terrace that forms the top of the present day seacliff are exposed to surf action where the terrace has been extensively downwarped (figures 9, 10). In these locations, the bedrock portion of the cliff may be 1.5 to 3 m high, or less, leaving little resistance to wave action. In these cases, the terrace deposits are usually stripped off the platform, and cliff retreat is rapid, up to 50 cm/year.

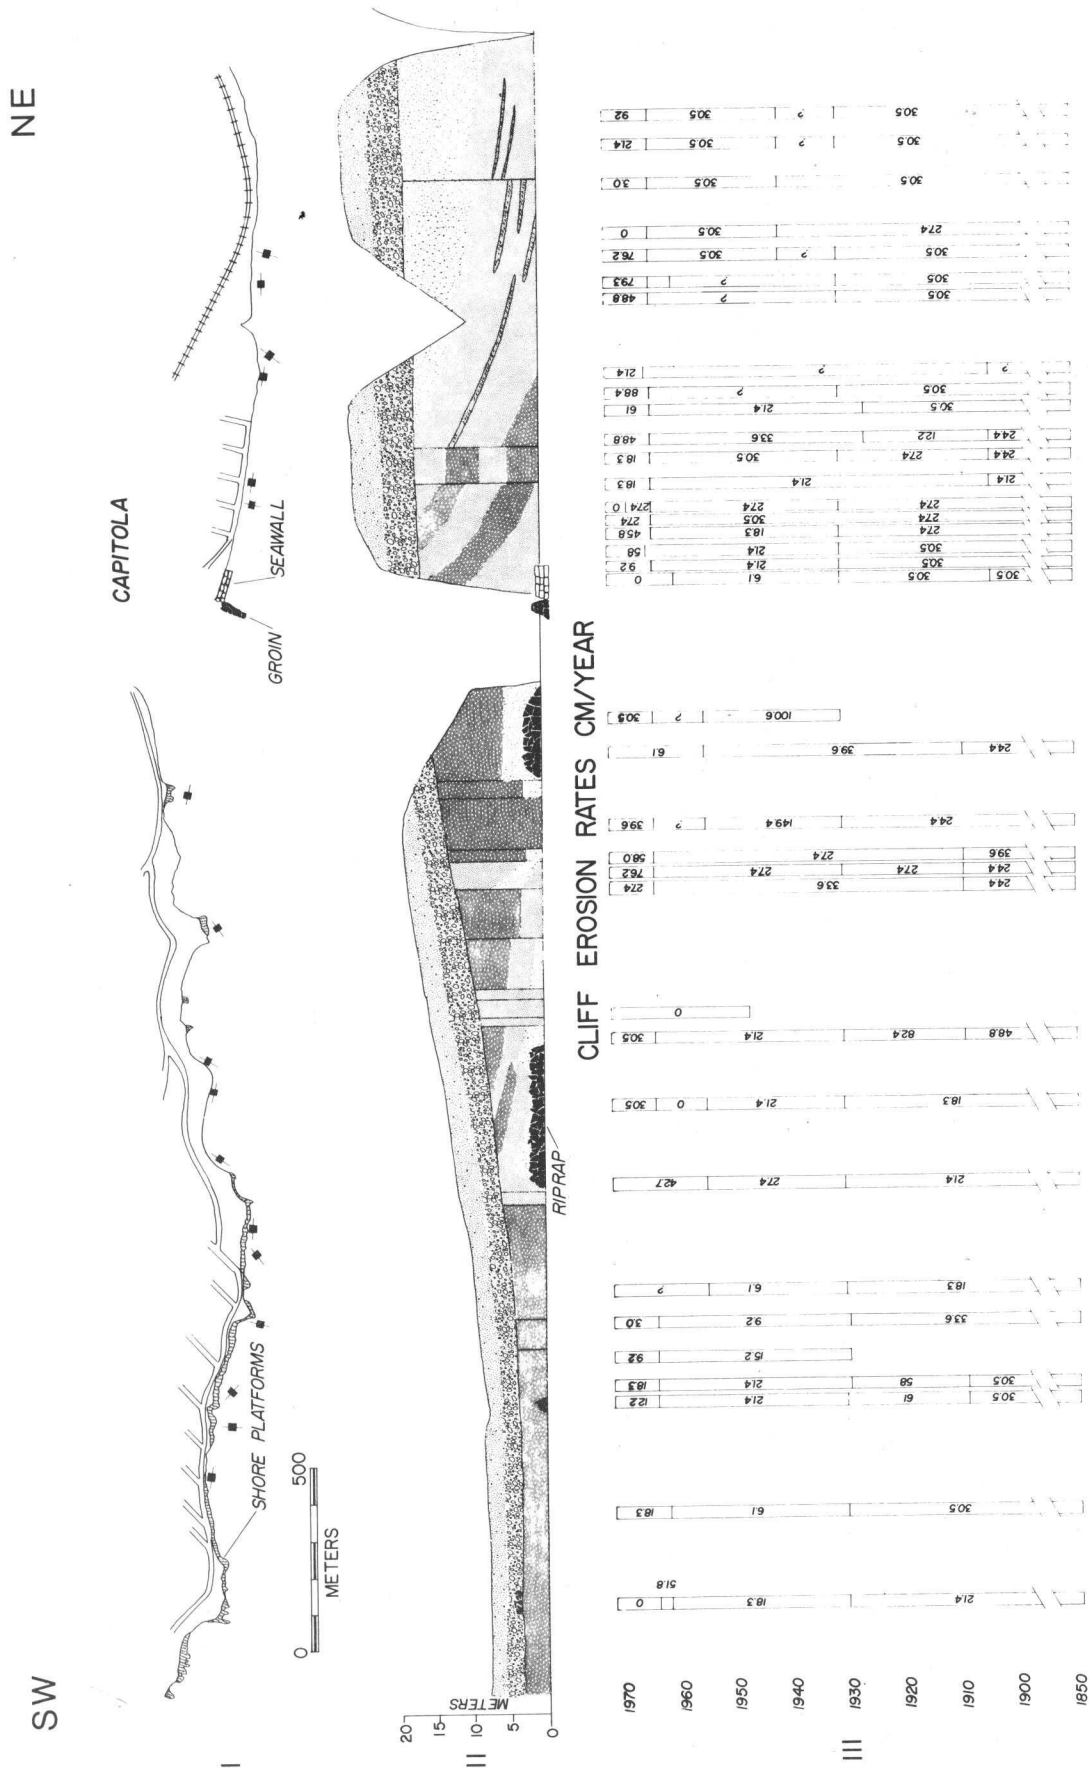
Figure 10. Plan view (I), geologic cross section (II), and long term average erosion rates along northern Monterey Bay from Sequel Point to Capitola (III). Note joint orientations on plan view, variations in elevation of terrace height, faulting in the bedrock, and shell horizons within the Purisima Formation. Erosion rates are shown for specific intervals for which control exists.

The stretch of coast from Capitola Beach southwestward to New Brighton Beach (figure 10) is composed of well-jointed erodible beds within the Purisima Formation. The combination of erodible material and lack of a significant protective beach has led to severe cliff retreat along 1.5 km of ocean front. The lack of a protective beach is due to the fact that the cliff line is oriented in a direction conducive to high rates of littoral drift, and also because there is no structure downcoast to trap littoral materials. The average erosion rate in this area over the past 100 years has been about 30 cm/year. In the last 5 or 10 years, rates of 45 to 90 cm/year have been occurring (figure 10). As a result, the foundations of apartment

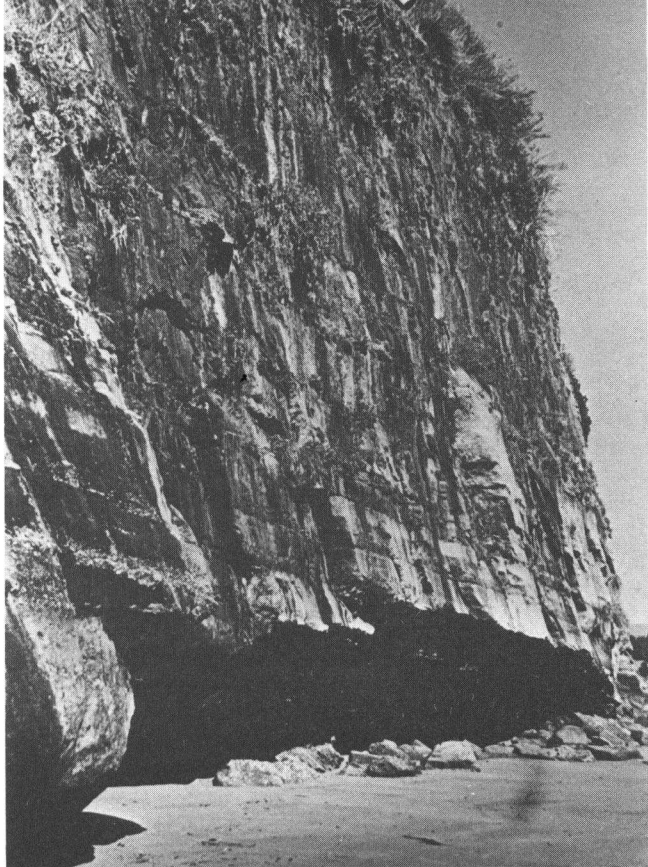
Figure 11. Erosion of a weak stratigraphic unit within the Purisima Formation near Capitola has undercut the seacliff. Photo by R.E. Johnson.

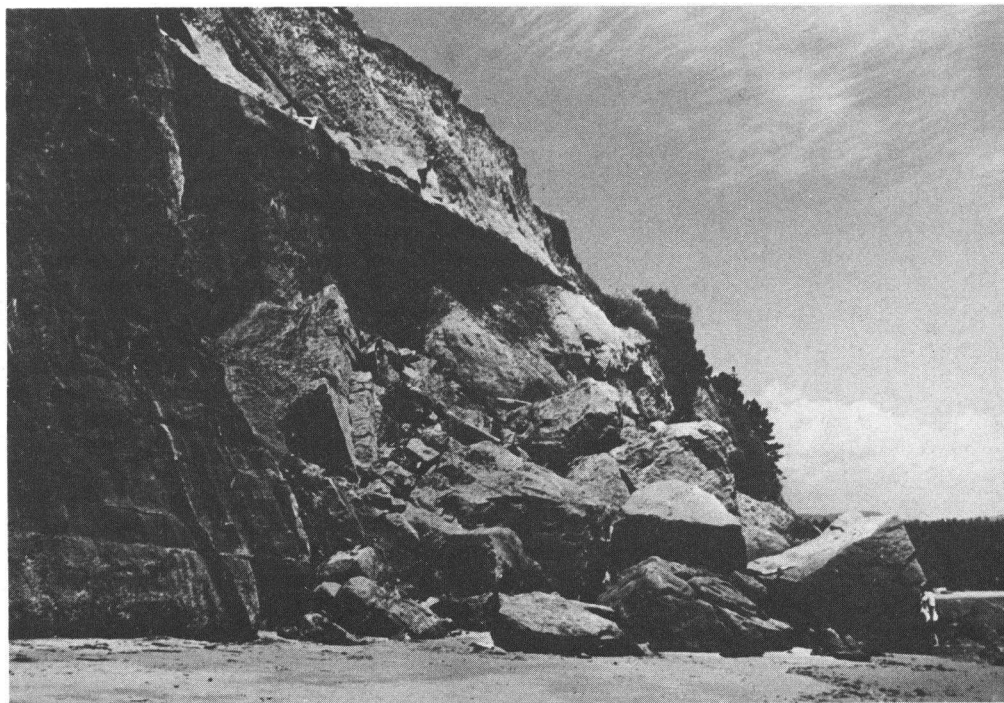
Figure 12. Large blocks of sandstone and siltstone have fallen to the beach due to failure along joint sets and undercutting by surf action. Note person on right side of photo for scale. Photo by R.E. Johnson.

Cliff height sometimes exerts an indirect control on erosion rates. The quantity of material produced by a given amount of coastal retreat is a direct function of cliff height. For example, cliffs have been undercut and have subsequently failed, and large blocks have broken out along joint sets and fallen to the beach below (figure 12). To the extent that this material remains in place at the foot of the cliff, it serves as temporary riprap to buffer the cliffs from direct wave attack. However, the large sandstone and siltstone blocks produced by breakdown of the Purisima Formation last only a few years in the surf zone.

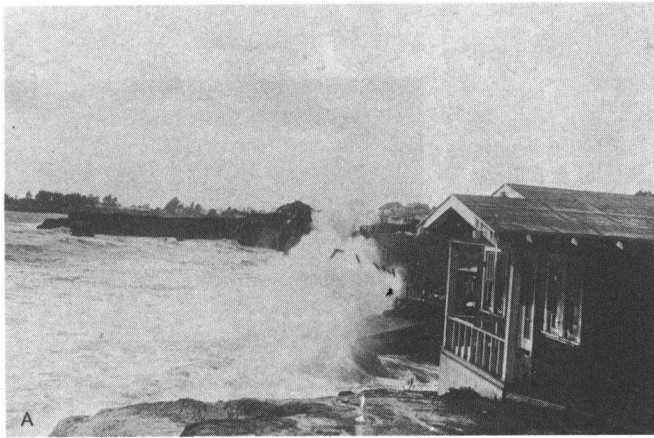
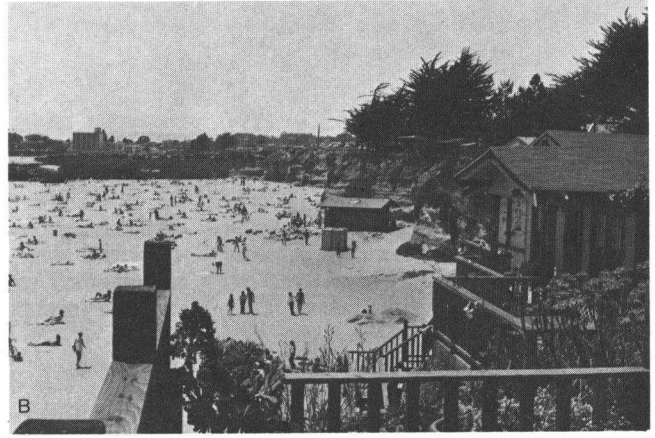
Figure 13. Jetties constructed as a part of the Santa Cruz small craft harbor have had an effect on coastal erosion processes in northern Monterey Bay. A. Seabright Beach (between San Lorenzo River and harbor) during a 1925-26 winter storm. *Photo by Dorothy Miller.* B. Same view, summer 1976. Waves from winter storms no longer attack the low cliffs (background) due to the protective beach built up against the west jetty of the harbor. *Photo by Ann Carlson.*

Two jetties constructed as part of the Santa Cruz small craft harbor have had an effect on coastal processes in northern

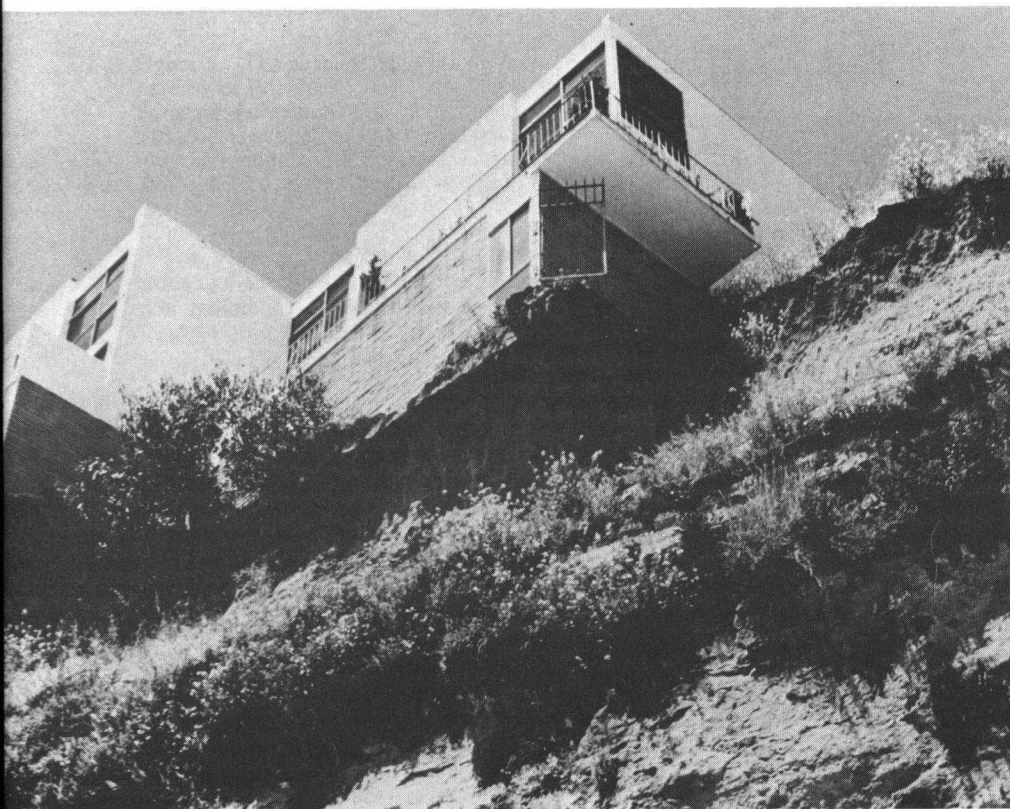
Figure 14. This seacliff in the Purisima Formation is jointed and erodible. Severe cliff retreat has undercut the foundations of buildings along the coast in the Capitola area. *Photo by G.B. Griggs.*

buildings on the seacliff have been gradually undercut, leaving portions of the concrete foundations unsupported (figure 14). A similar failure continues to occur in the area; the exceptionally severe storms of the 1977-78 winter caused numerous failures along this stretch of coast. No structures were immediately endangered during the 1977-78 winter but some may be endangered within 5 to 10 years.

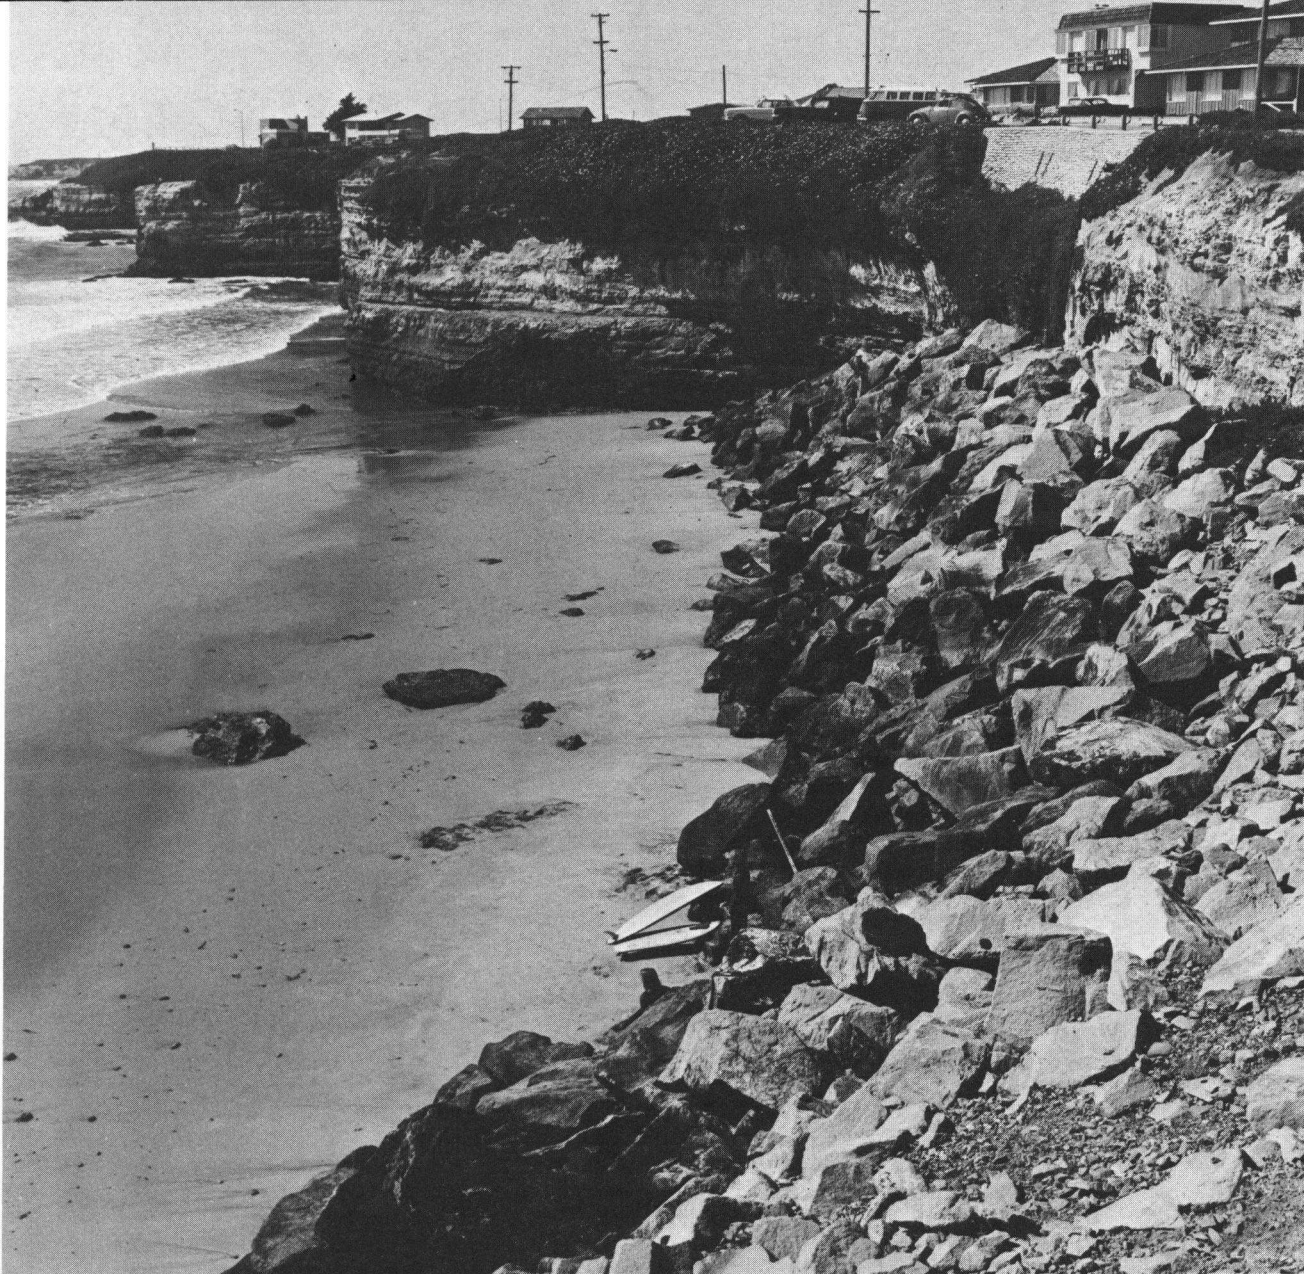
Figure 15. Riprap has been placed at the foot of the low cliff to retard coastal erosion. *Photo by R.E. Johnson.*

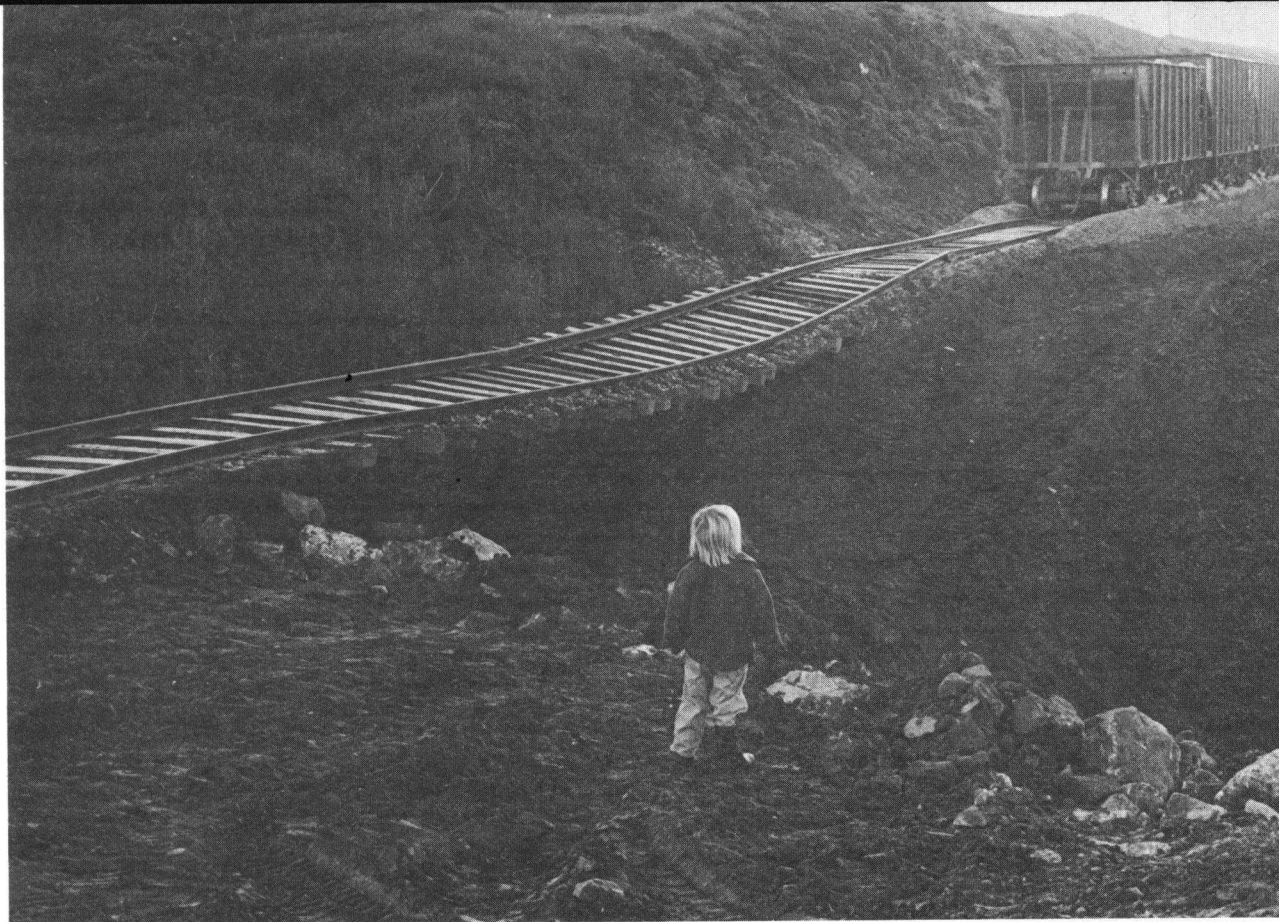
Figure 16. Railroad track embankment 1 km south of Davenport. Heavy rain and runoff during the winter of 1973, combined with surf action, undercut this track built across a cove. Photo by G.B. Griggs.

Although the overall long term erosion rates in the Santa Cruz Mudstone along the exposed coast northwest of Santa Cruz are relatively low, episodic seacliff retreat in certain places has led to problems. Near the town of Davenport heavy rains and runoff during 1973 combined with surf action to undercut the Southern Pacific Railroad track. A cove was extended landward, leaving about thirty feet of train track suspended in mid-air (figure 16). Farther north, in the vicinity of Waddell Creek, State Highway 1 has been constructed on fill at the base of high, steep cliffs in intensively fractured Santa Cruz Mudstone. A resistant bed in the surf zone has acted as a natural groin to trap littoral drift upcoast, forming a pro-

TECTIVE beach. The road-fill on the down-coast side was unprotected and rapidly eroded until protective riprap was emplaced.
